Debris/Ice/TPS Assessment and Integrated Photographic Analysis of Shuttle mission STS-102

Technical Memorandum – 2001 – 210257

May 2001

**DEBRIS/ICE/TPS ASSESSMENT
AND
INTEGRATED PHOTOGRAPHIC ANALYSIS
OF
SHUTTLE MISSION STS-102**

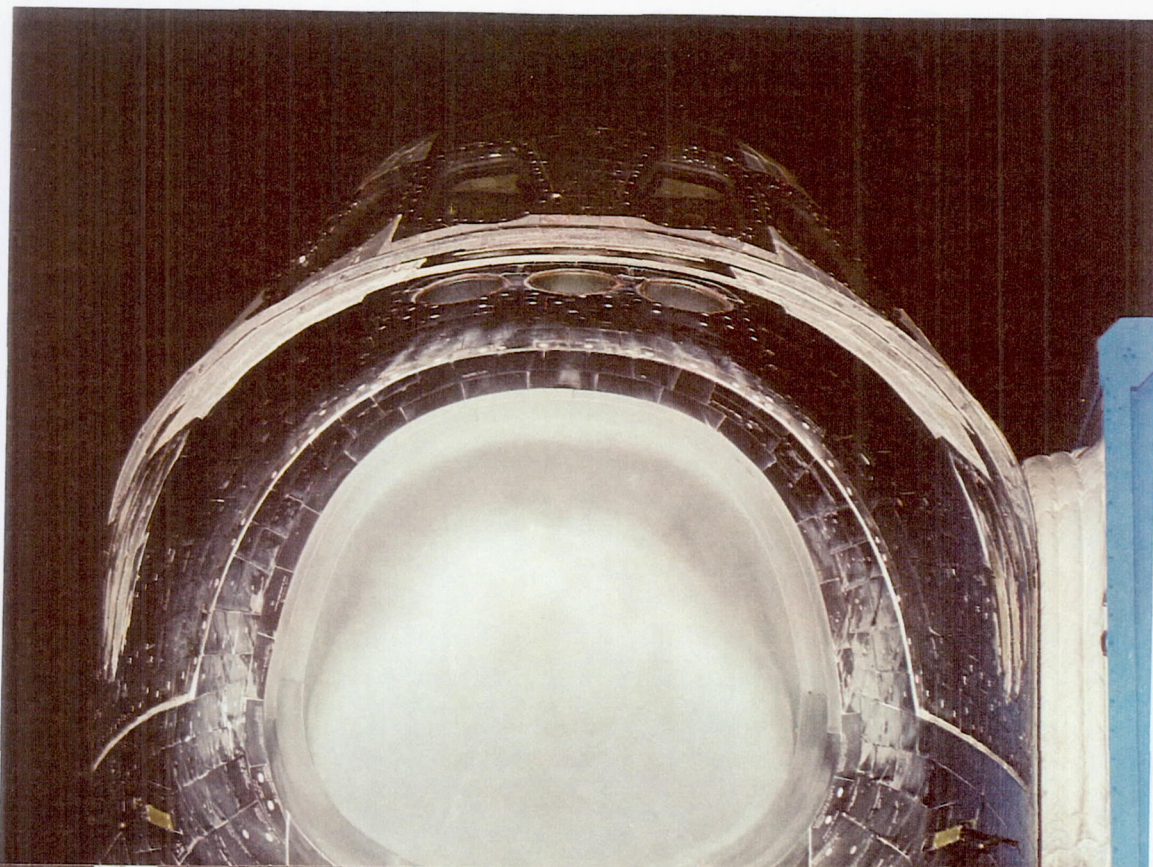
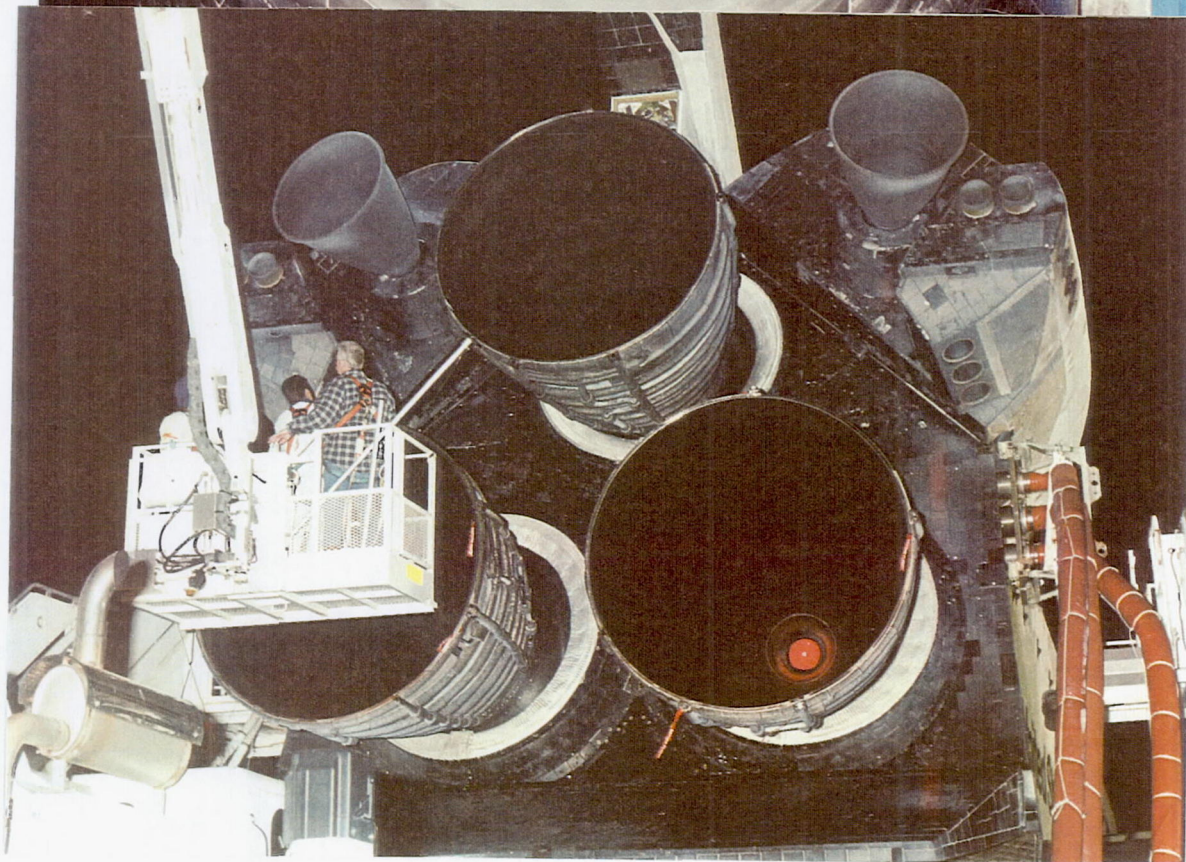
Photo 17: Windows and Base Heat Shield

Damage sites on the window perimeter tiles were more than usual in quantity. Less than usual amounts of tile damage occurred on the base heat shield. All SSME Dome Heat Shield closeout blankets were in excellent condition.

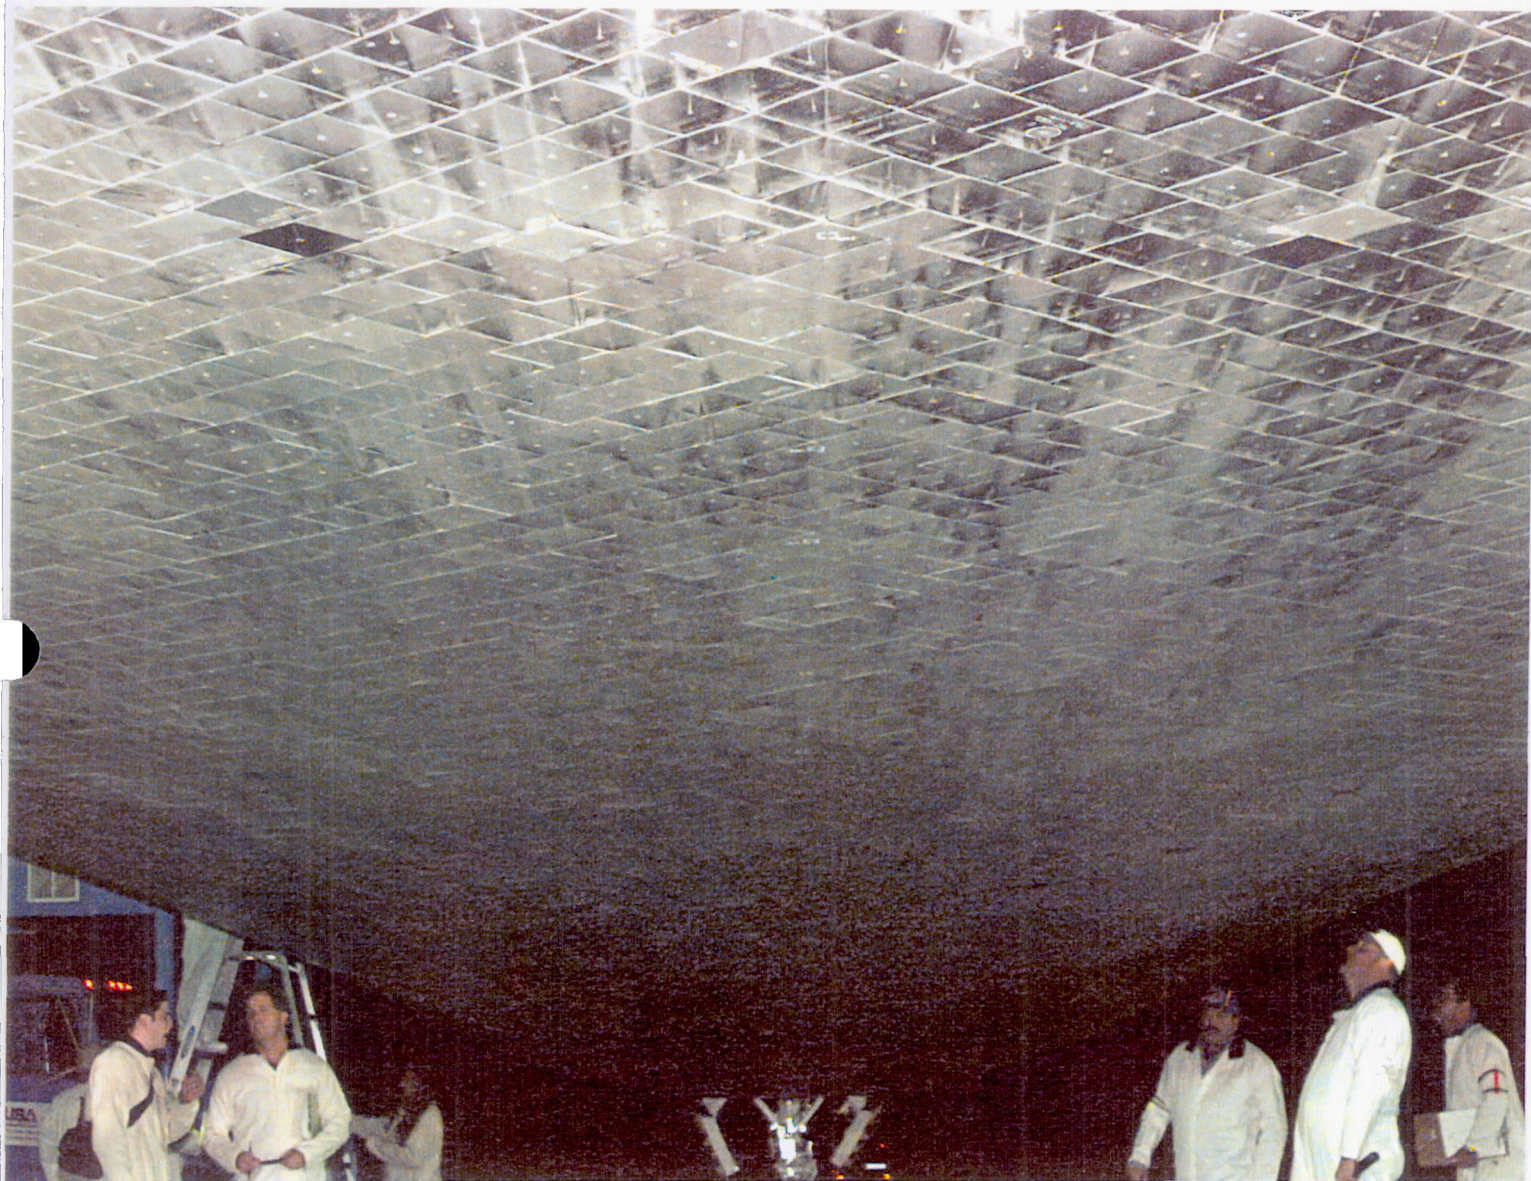
Photo 18: Damage to Lower Surface Tiles

The Orbiter lower surface sustained 44 total hits, of which 10 had a major dimension of 1-inch or larger, both numbers are well within family. Approximately 14 damage sites (with two larger than 1-inch in length) were located in the area from the nose landing gear to the main landing gear wheel wells. The majority of the hits were around the LH2 umbilical area (22 hits). Most of these damage sites around the ET/ORB umbilical were most likely caused by pieces of the umbilical purge barrier flailing in the airstream and contacting tiles before pulling loose and falling aft.

The orbiter lower surface sustained only 44 total hits. Both the total number of Orbiter TPS debris hits and the number of hits 1-inch or larger were well within established family

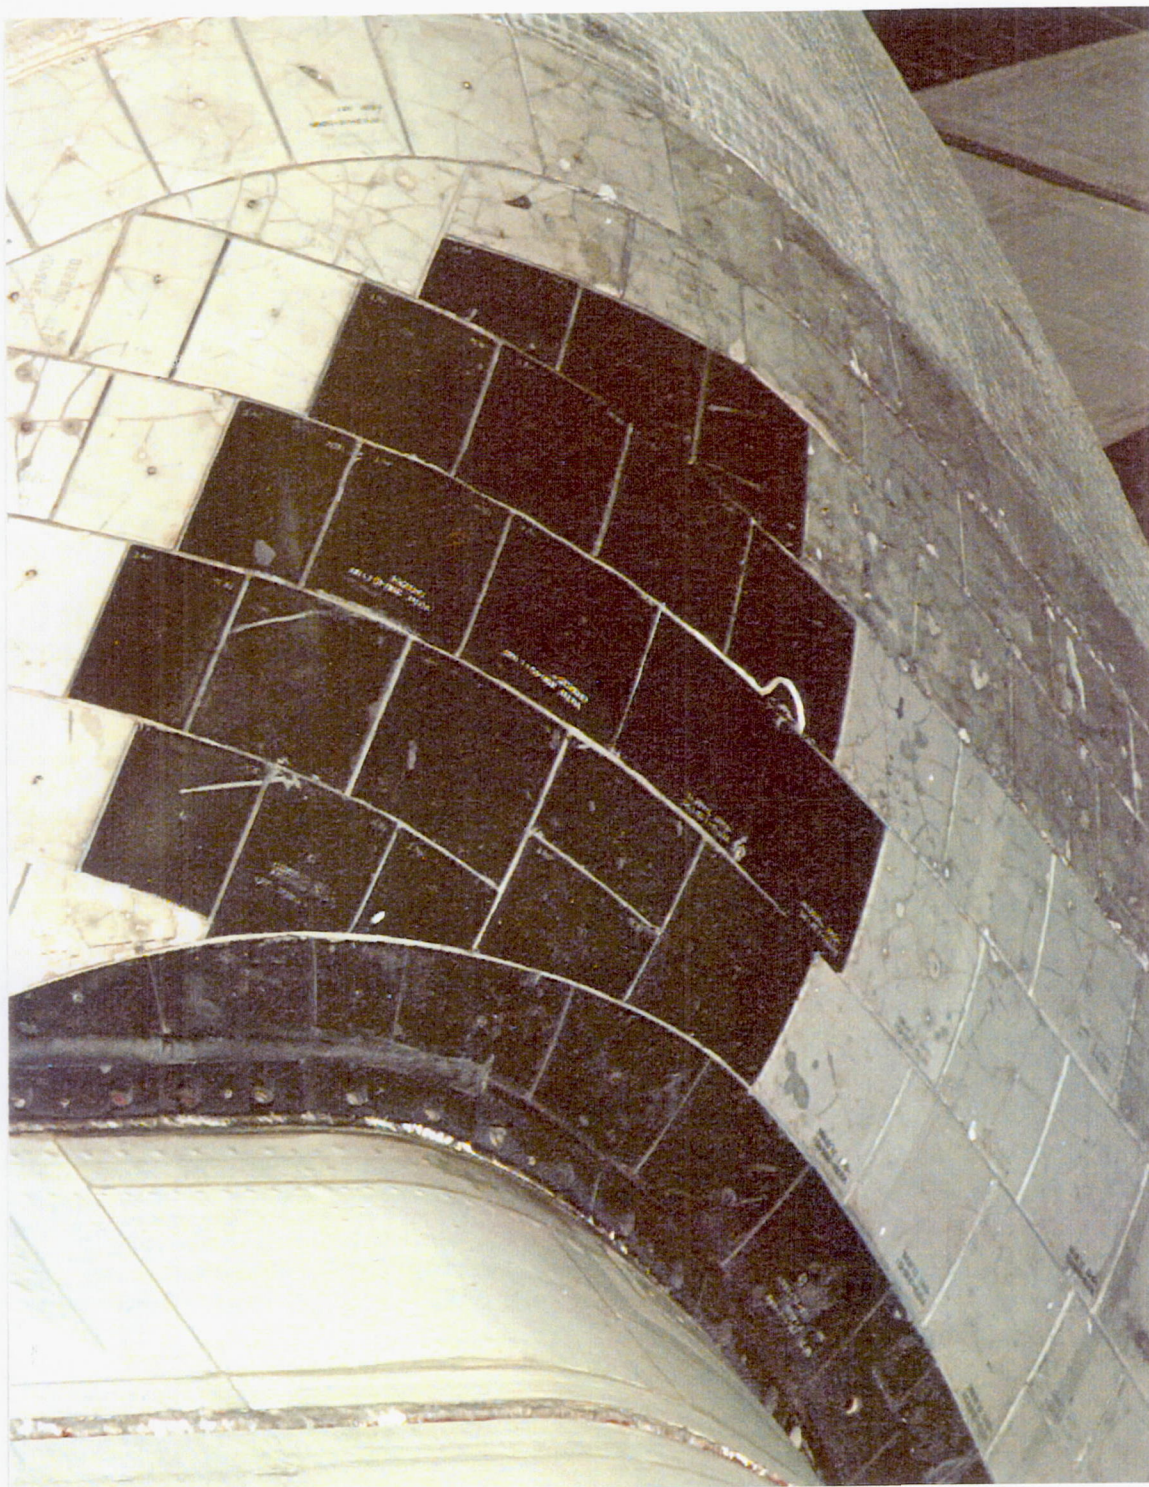
Photo 19: R/H OMS pod

One protruding tile gap filler material was found on the R/H OMS pod, approximately 2 inches long.

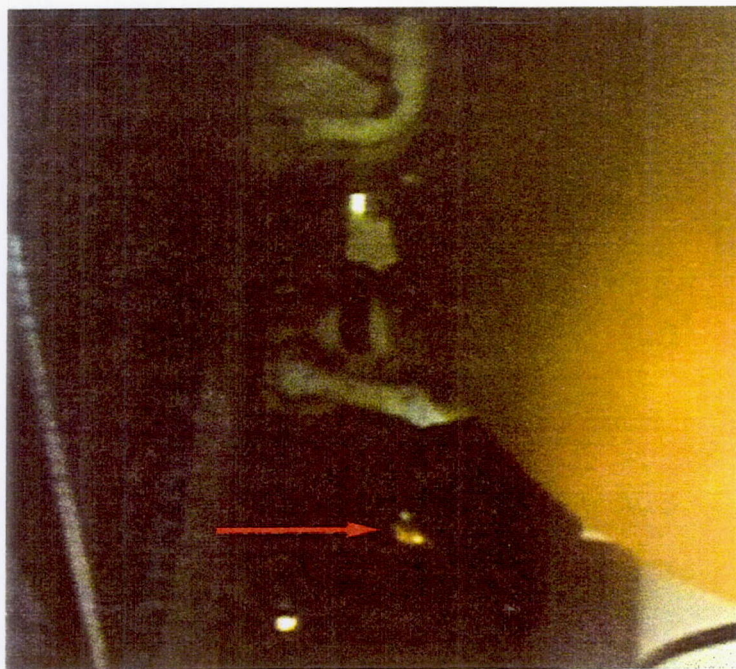
Figure 2.2.1 (A) Large Flexible Debris Near LH2 Umbilical Prior to Liftoff

A large piece of light-orange-colored flexible debris was seen falling from below the LH2 umbilical prior to lift off (11:42:07.3 UTC). This debris may have been a piece of umbilical well purge barrier material. (Camera OTV154)

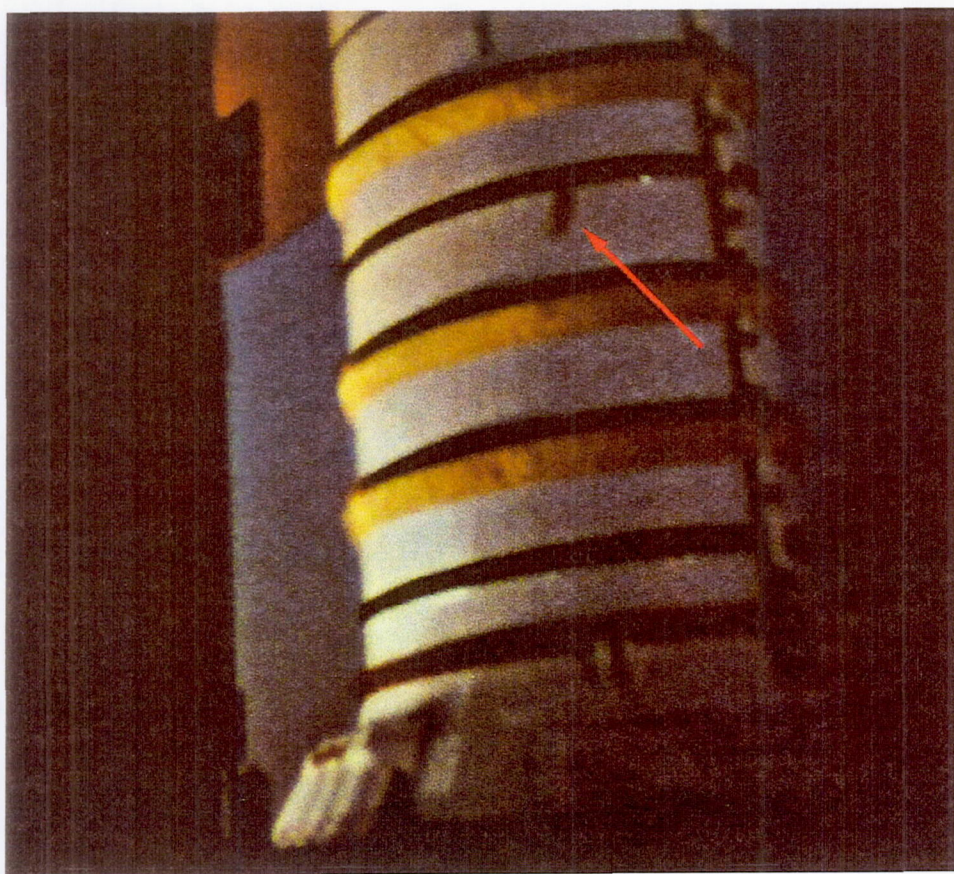
Figure 2.2.1 (B) Flexible Piece of Debris near North Side of LO2 TSM Prior to Liftoff

On camera E2, a large flexible piece of umbilical purge barrier material debris seen on the north side of the LO2 TSM, traveled near the RSRB, and fell aft to the deck of the MLP (11:42:08.891 UTC). See Figure 2.2.1 (B). During liftoff, a piece of ET / Orbiter umbilical purge barrier material was seen to be partially detached before breaking away and falling aft (Camera E31, 11:42:10.794 UTC). The remaining visible umbilical purge barrier material was seen flapping against the Orbiter tiles. The flapping of this material could have resulted in the tile damage found post-landing near the ET / Orbiter umbilicals. After the roll maneuver, another large piece of umbilical purge barrier material was seen falling aft of the vehicle. Umbilical purge barrier material debris has been seen during ascent on previous missions. (Cameras E2, E4, E5, E31, E54, E207, E223)

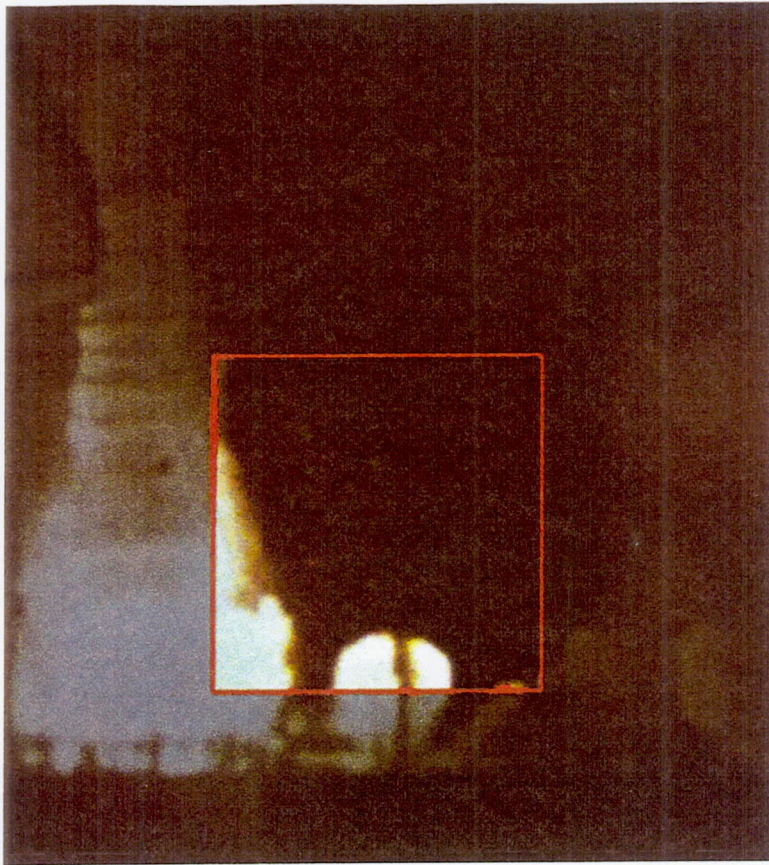
Figure 2.2.1 (C) Debris from SRB Flame Ducts at Liftoff (Camera E222)

Typical of many previous missions, several light-colored pieces of debris were seen traveling from the area of both the right and left SRB flame ducts (probably SRB throat plug material or SRB aft skirt instafoam) in a northerly direction away from the launch vehicle after SRB ignition (11:42:10.838 UTC). A larger, light-colored debris object was seen on the north side of the vehicle at a higher elevation than the other debris. This object was concluded to have been a bird. On camera E1, a piece of probable throat plug material, seen near the left SRB aft skirt, traveled in a +Y direction toward the RSRB and the LO2 TSM. On camera E5, a piece of probable SRB throat plug material was seen moving from near the aft end of the SRB's toward the body flap at liftoff. A single piece of light-colored debris (probable SRB aft skirt instafoam) was seen near the RSRB aft skirt area moving away from the vehicle during liftoff. None of the debris was seen to contact the launch vehicle. (Cameras OTV163, E1, E4, E36, E63, E222, E223, E224)

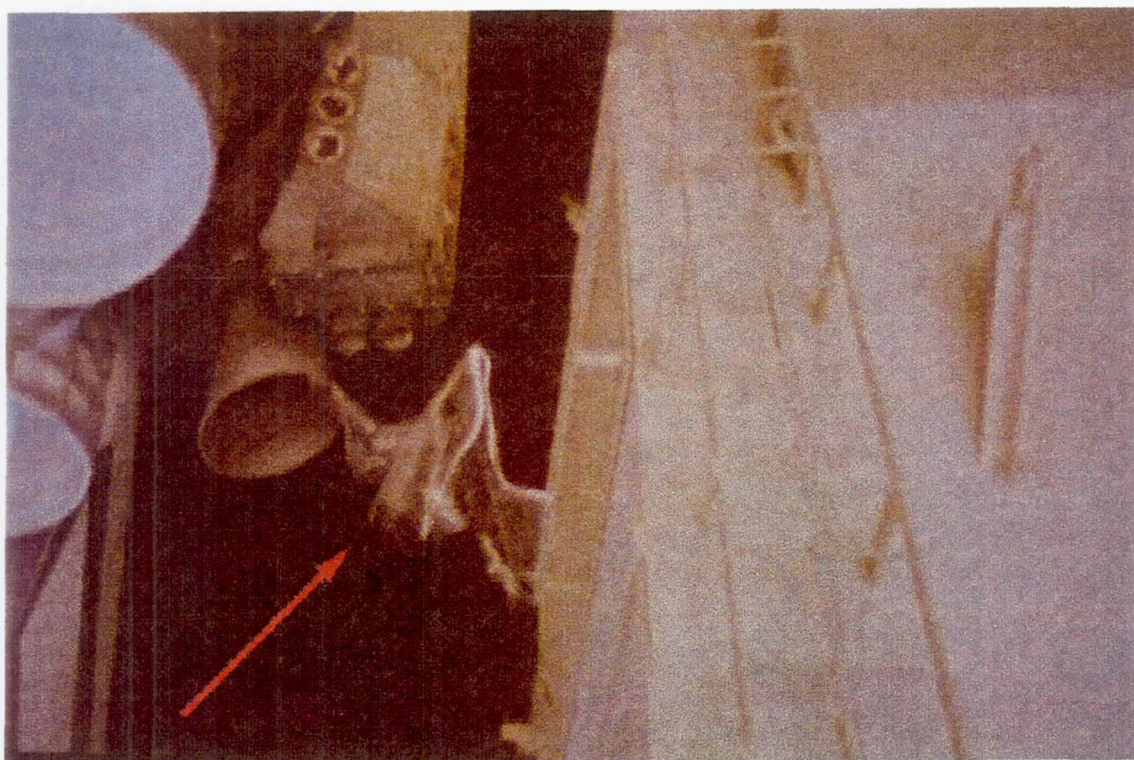
Figure 2.2.3 Barrier Material from LH2 TSM Falling During Liftoff (Camera E18)

A large, clear, piece of flexible closeout / barrier material from the LH2 TSM umbilical compartment was seen falling just after the LH2 TSM umbilical carrier had retracted. (11:42:10.421 UTC). See Figure 2.2.3. (Camera E18, E19)

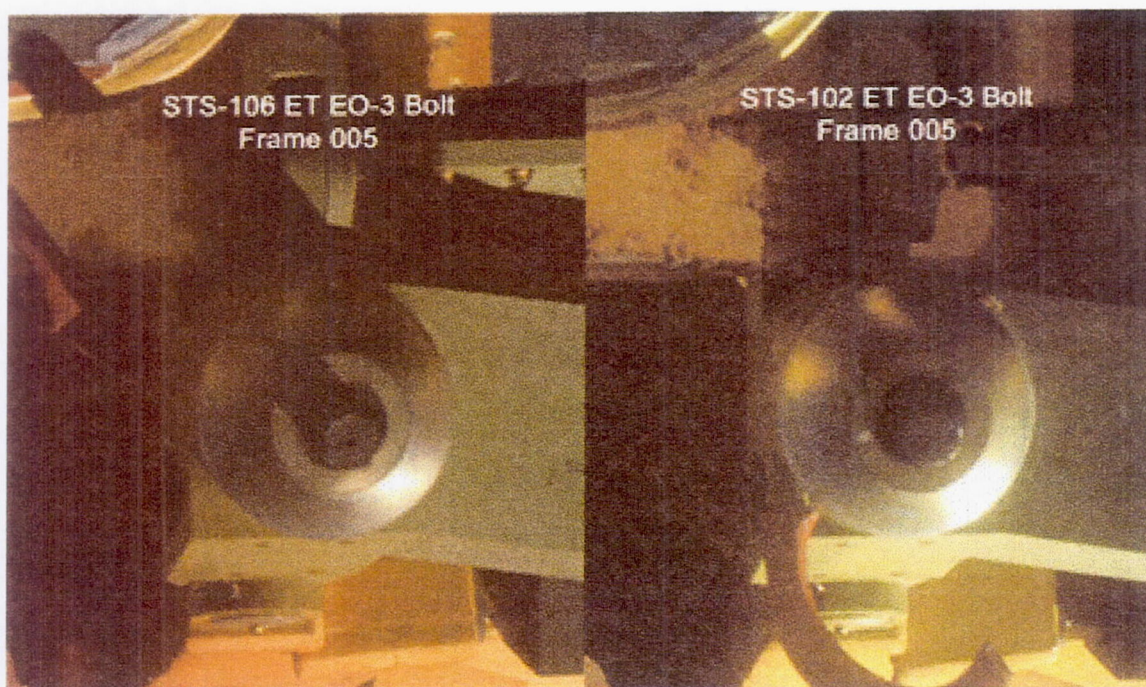
Figure 2.3.2 (A) Comparison of STS-106 and STS-102 ET EO-3 Unretracted Bolts

The separation bolt between the ET and the Orbiter at the aft end of the ET (EO-3 fitting near the liquid oxygen umbilical) was confirmed not to be fully retracted as viewed from the umbilical film. See Figure 2.3.2 (A), image on right. Comparing successive frames, a lateral motion of the bolt was determined to have been present. The EO-3 bolt appeared similar to the protruded EO-3 bolt seen on the STS-106 umbilical well camera film. See Figure 2.3.2 (A), image on left. An attempt to measure the length of the STS-102 unretracted bolt using a parallax method with pairs

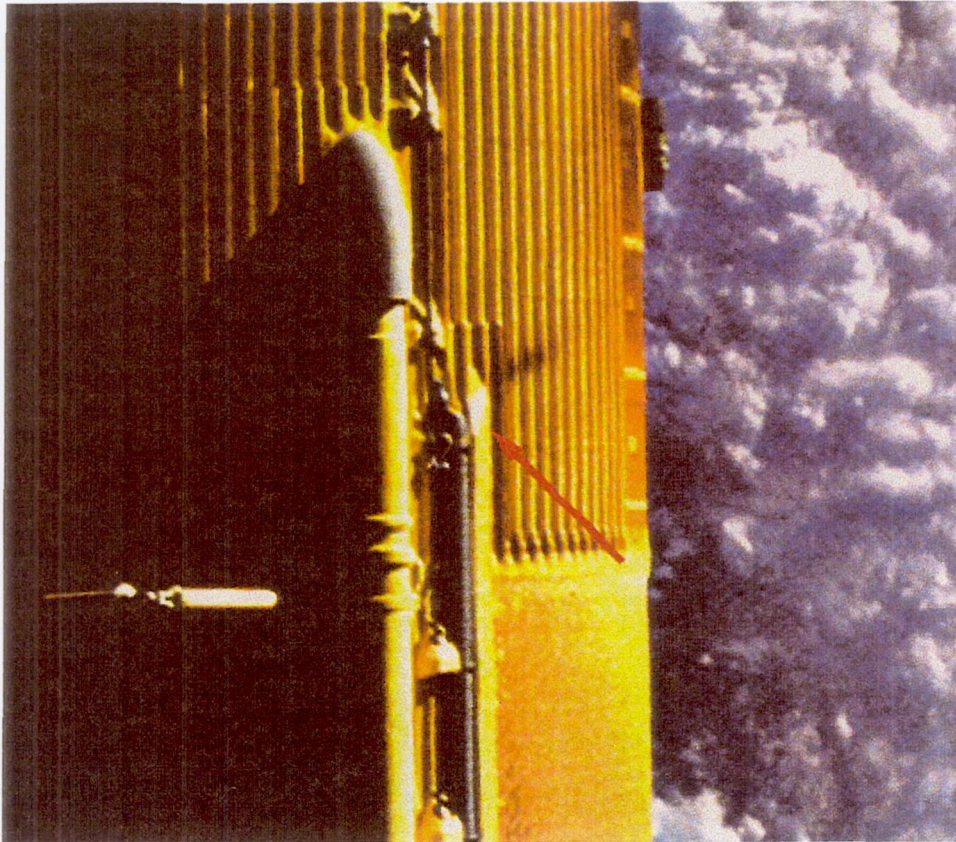
Figure 2.3.2 (B) 35mm Umbilical Well Camera View of ET Intertank

An approximately nine inch long white-colored mark (possible TPS ablation) was visible on the forward end of the PAL ramp (just aft of the forward LO2 feedline bellows). See Figure 2.3.2 (B).

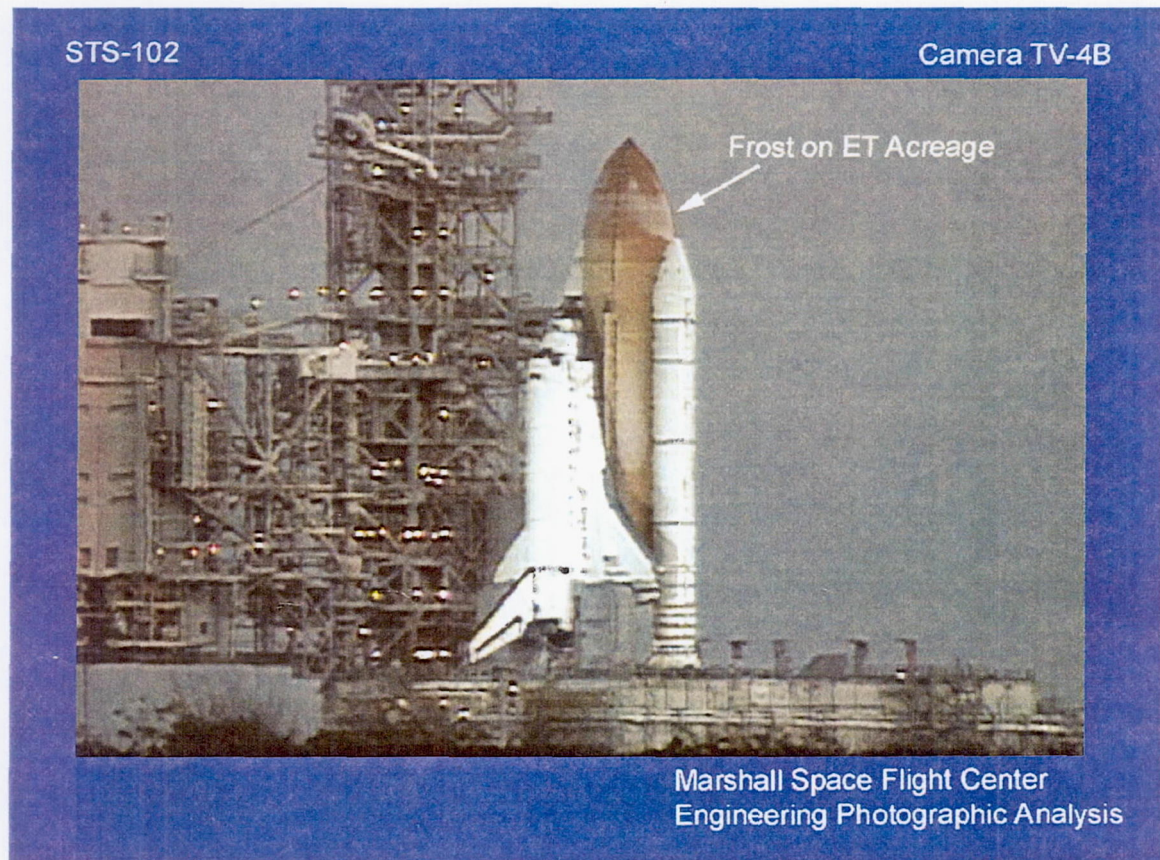
Figure 1. Frost on ET Acreage

A large area of the External Tank was coated with frost prior to liftoff. Frost was not observed on later film/video and assumed to have sublimed or evaporated quickly during vehicle ascent.

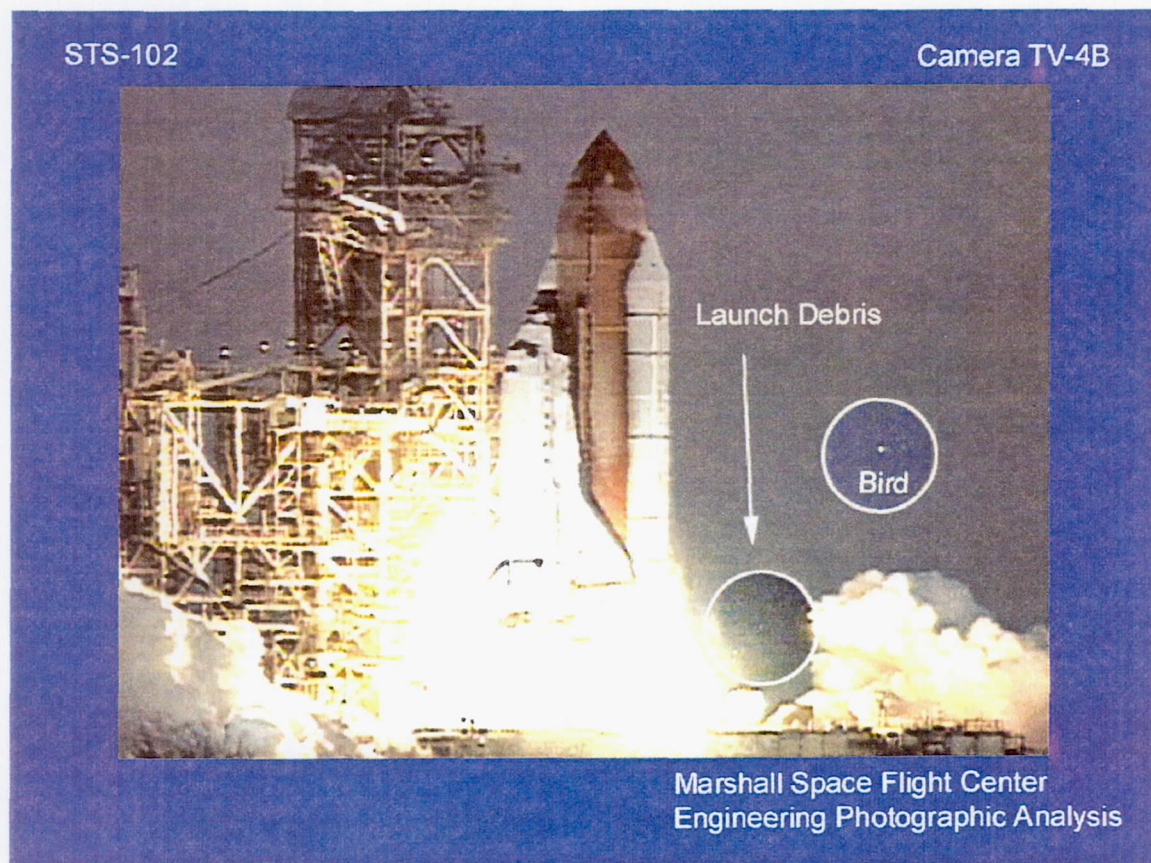
Figure 2. Pad Debris at SRB Ignition

Several typical launch pad debris items were observed at SRB ignition. A bird was also observed near the launch site.

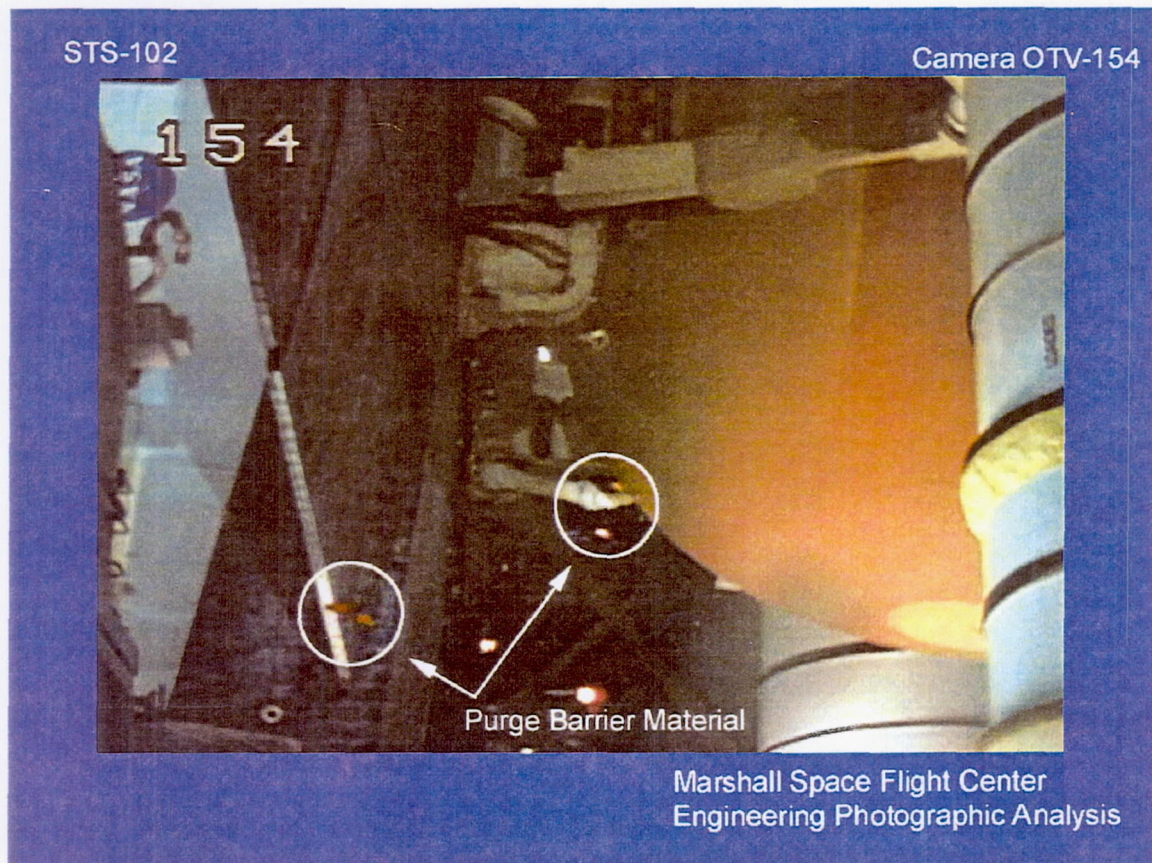
Figure 3. Purge Barrier Material Debris

Several pieces of purge barrier material debris were observed falling through the field of view. These appeared to come from both the LOX and LH2 17-inch disconnects.

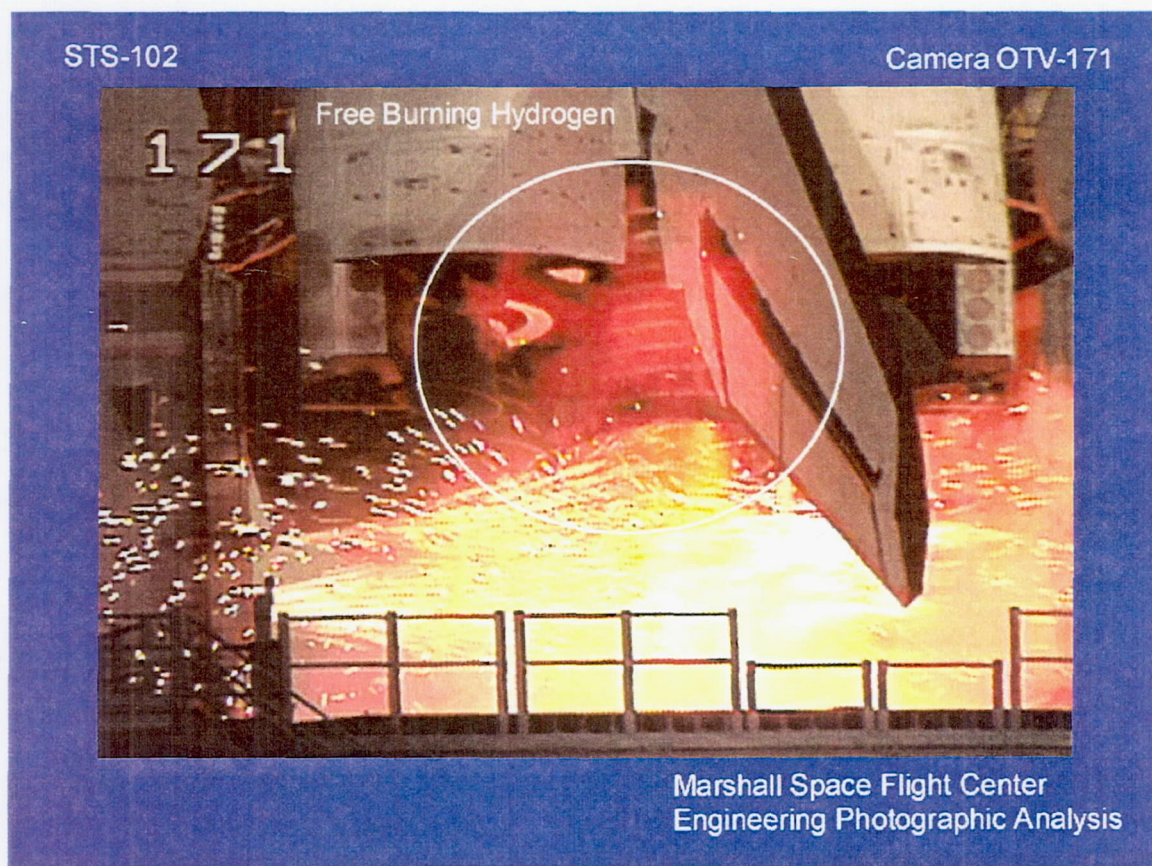
Figure 4. Free Burning Hydrogen at SSME Ignition

Free burning Hydrogen was observed at SSME ignition, extending forward of the -Y (left) OMS Pod rim. This particular phenomenon is a typical occurrence during SSME ignition and appears to be within normal limits.

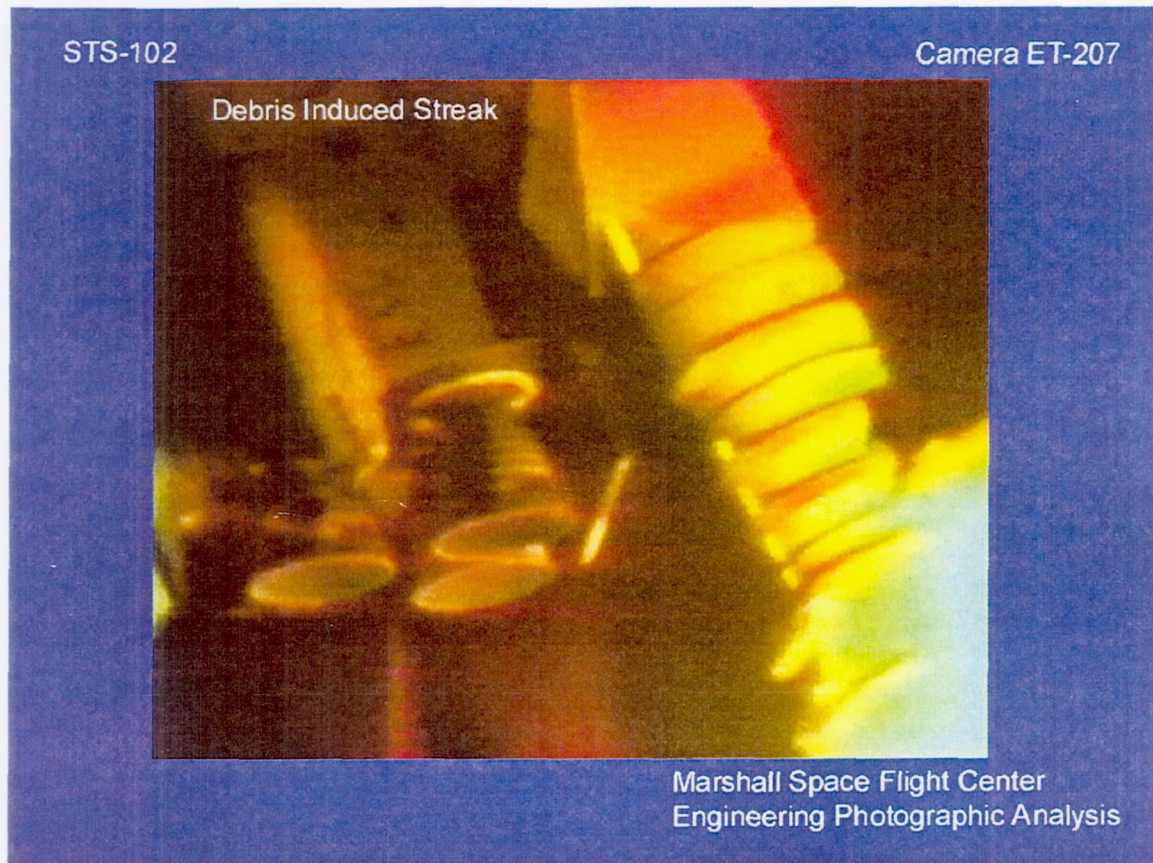
Figure 5. Debris Induced Streak in SSME Plumes

Several debris induced streaks in the SSME plumes were noted during ascent. Figure 5 illustrates one such event.

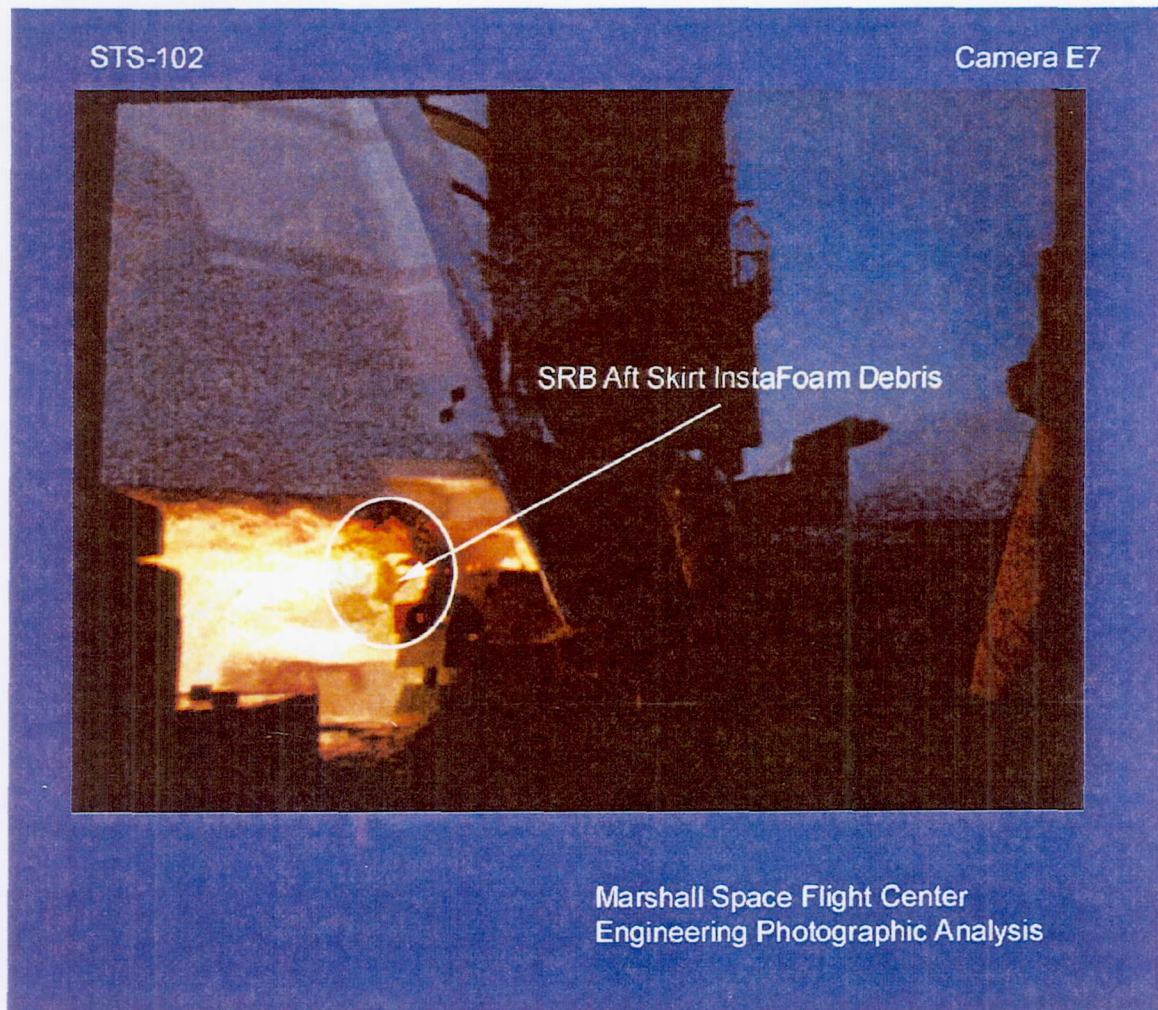
Figure 6. Instafoam Debris at Holddown Post M4

A notable chunk of Aft Skirt Instafoam was observed to break free after impact with the Shoe of Holddown Post M4.

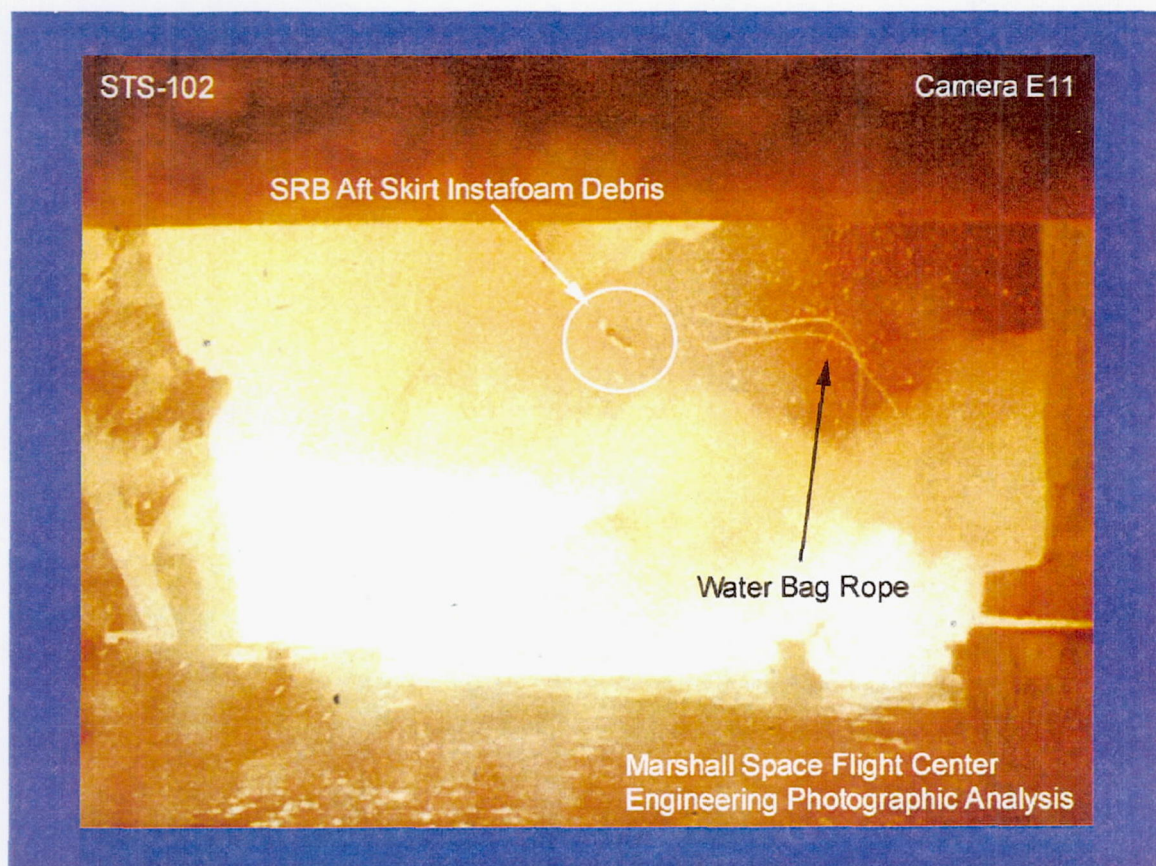
Figure 7. Instafoam Debris at Holddown Post M7

Another notable chunk of Aft Skirt Instafoam was observed free near Holddown Post M7.

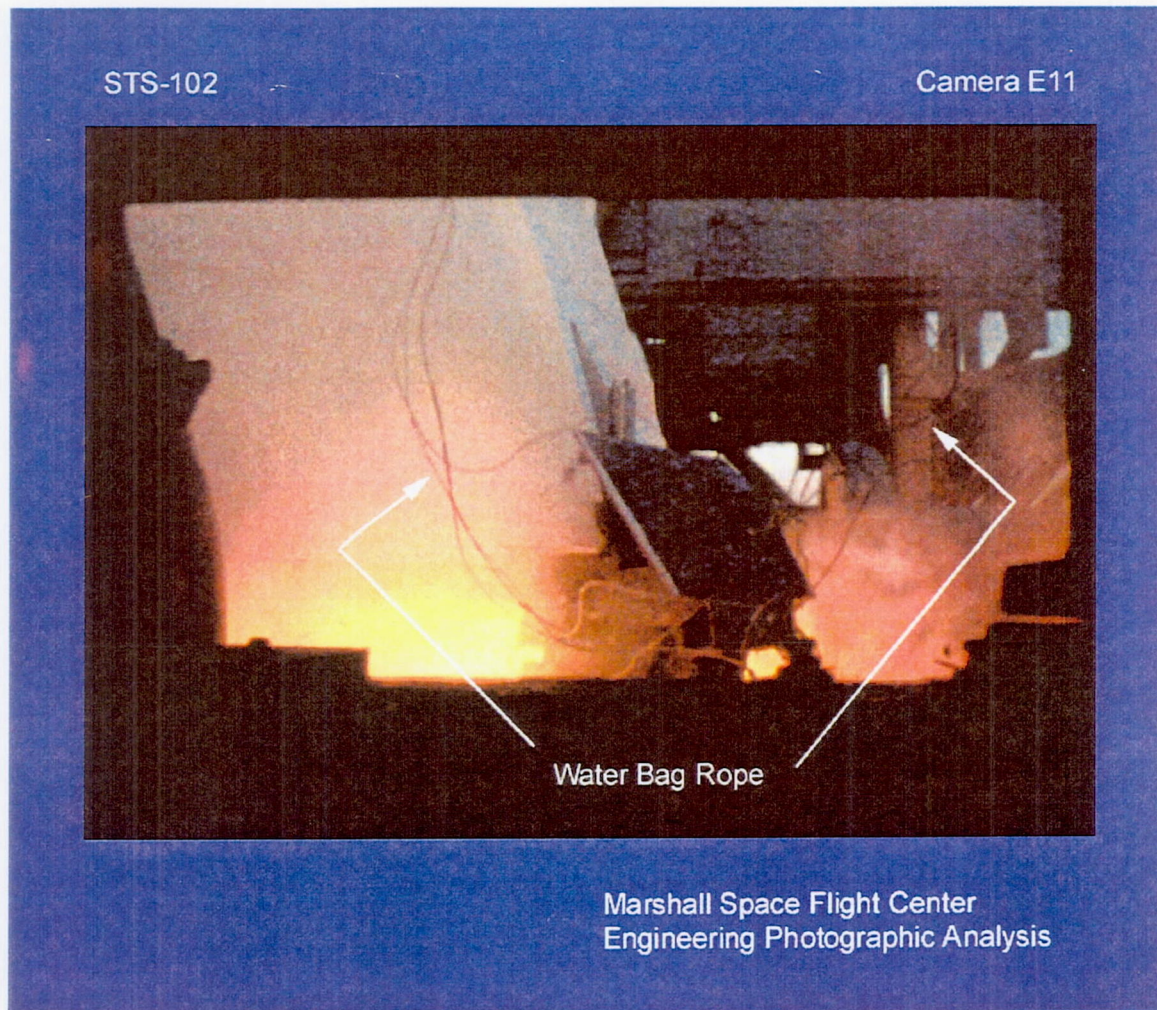
Figure 8. Tangle of Water Bag Ropes at Holddown Post M8

Several Water Bag Ropes were ejected from the SRB flame trench in the vicinity of Holddown Post M8. Water bag ropes have been observed on many previous missions. However, the number of these ropes was greater than usual.

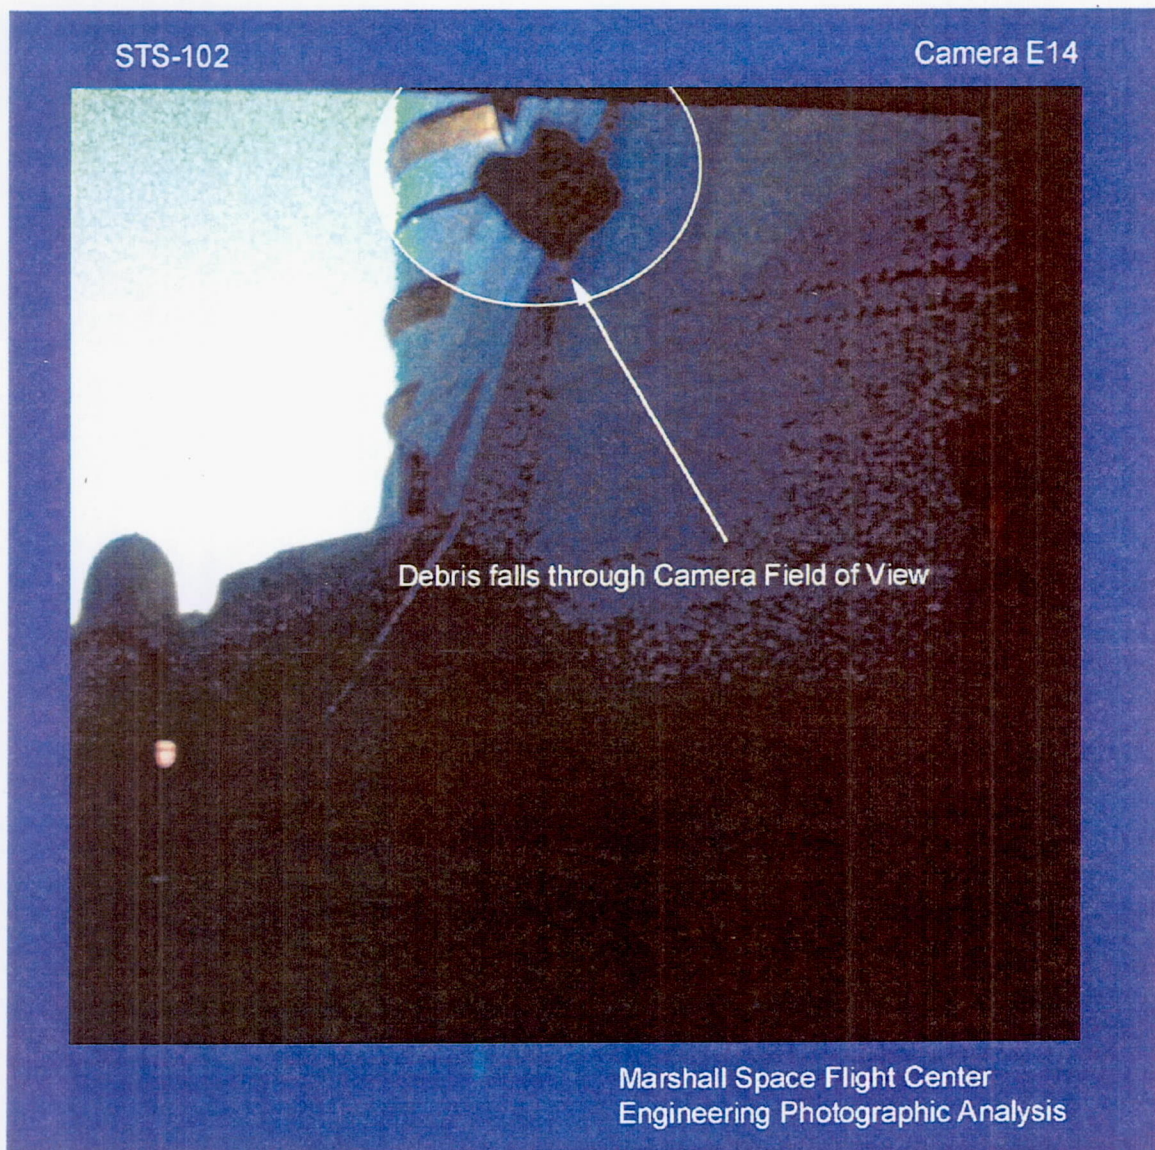
Figure 9. Launch Pad Debris Near Holddown Post M7

An unidentified, dark, somewhat notched debris item was observed near Holddown Post M7, falling through the field of view, just after SRB ignition. Since the object is out of focus, it is assumed to be near the camera.

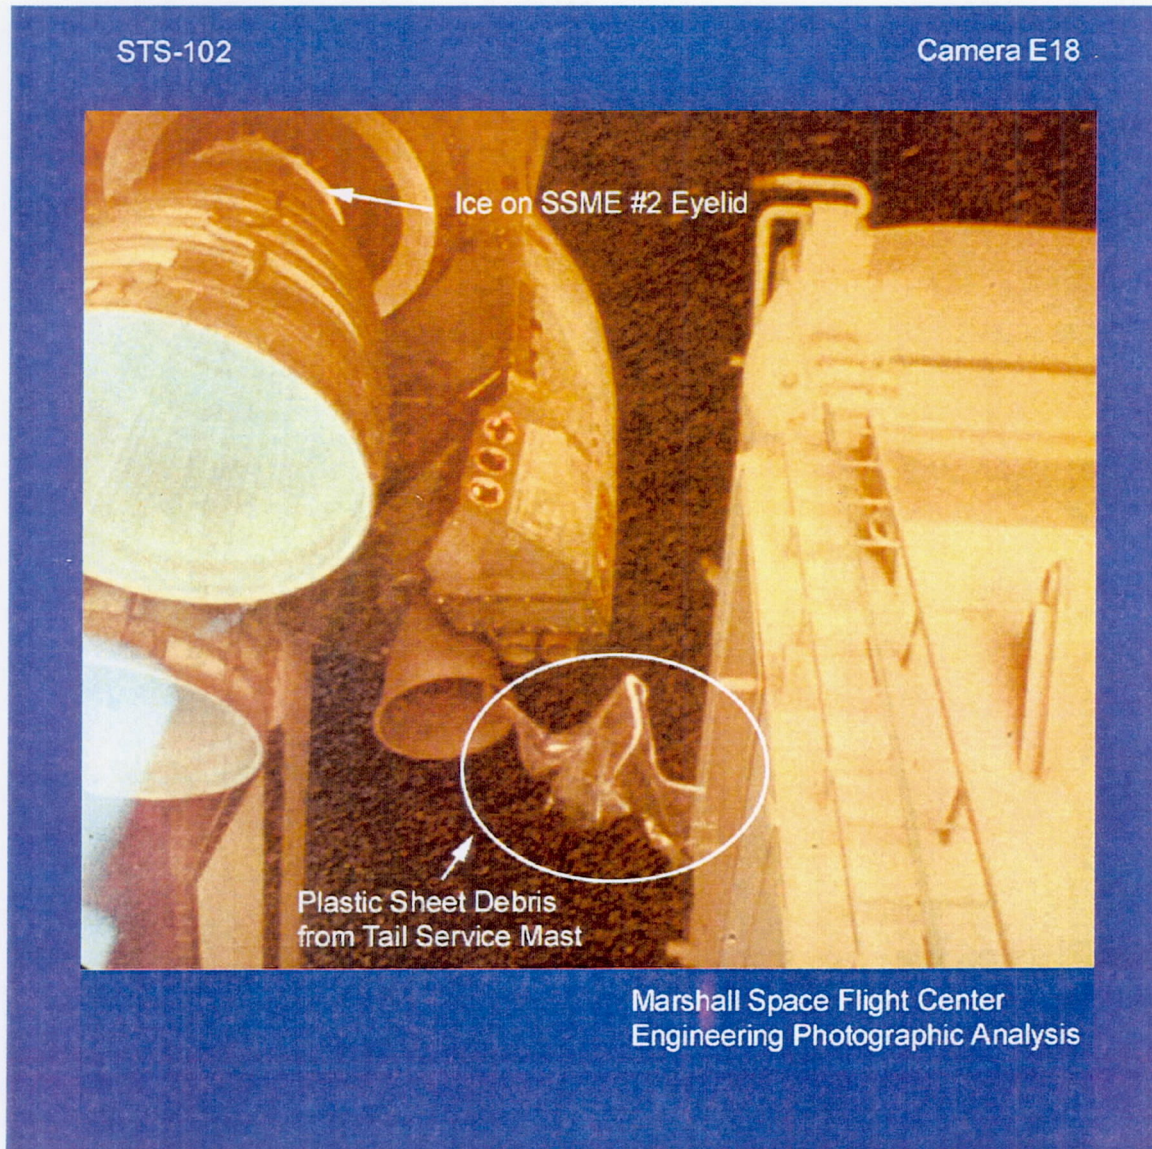
Figure 10. Debris from the Tail Service Mast

A sheet of plastic debris, identified as closeout/barrier material from the LH2 TSM Umbilical compartment, fell through the field of view, just after retraction of the LH2 T0 umbilical carrier. Also visible is ice around the SSME#2 eyelid.
